NASA  
Engineering Directorate  
Materials Science Division  
Kennedy Space Center, Florida

KSC-MSL-2011-0148

SUBJECT: Post STS-134 Evaluation of Main Flame Deflector Witness Materials

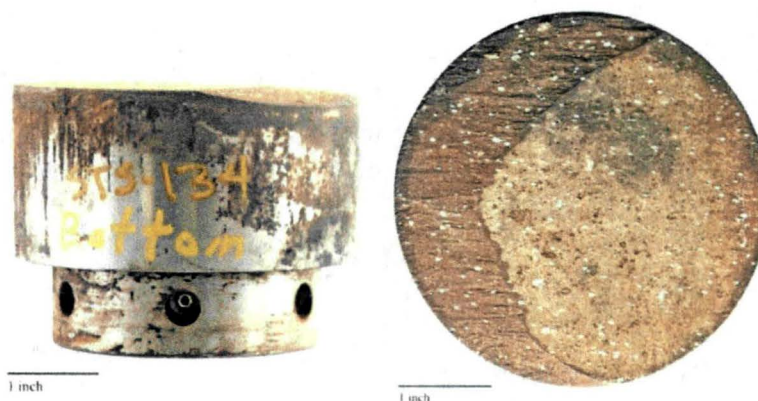
Figure 1. Bottom 1018 witness rod, as-received, profile (left) and top (right). Scale is one inch.

- 4.1. The 1018 witness rod samples were photographed, measured for dimensional changes, evaluated for microstructural differences, and tested to determine the microhardness profile. The bottom and top witness rod samples had visible erosion occur on the exposed surface of the witness rod. The bottom and top samples exhibited a transformation of the microstructure to untempered martensite in the heat affected zone at the surface of the witness rod due to heating during launch and quenching during water deluge. This transformation was confirmed by a significant increase in the hardness of the heat affected zone compared to the hardness of the ferrite and pearlite grains in the parent metal. The transformed microstructure is difficult to correlate with reference sources due to the severe conditions of launch. The bottom sample had a heat affected zone that was approximately 0.08 inch (2 mm) deep and the top sample had a heat affected zone that was approximately 0.06 inch (1.5 mm) deep. No apparent indications of melting were observed in the microstructure; however, the launch blast could have removed any evidence of melting.

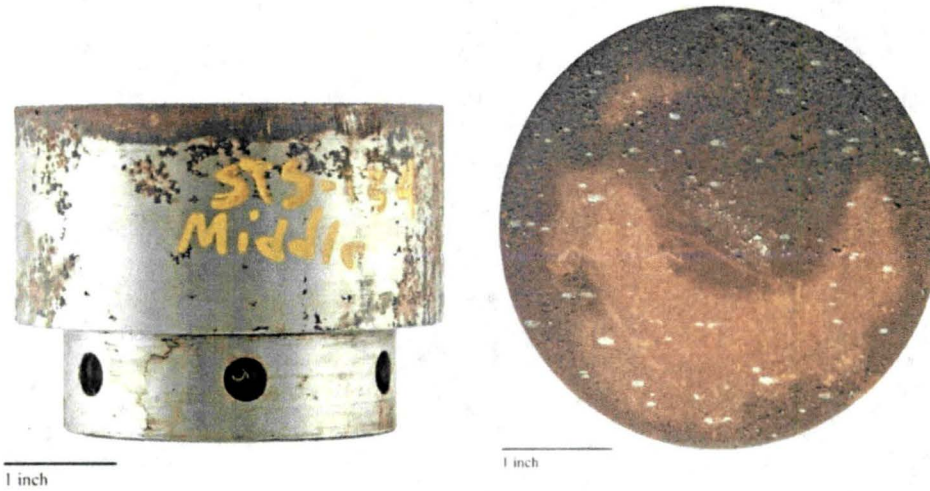
Figure 2. Middle 1018 witness rod, as-received, profile (left) and top (right).  
Scale is one inch.

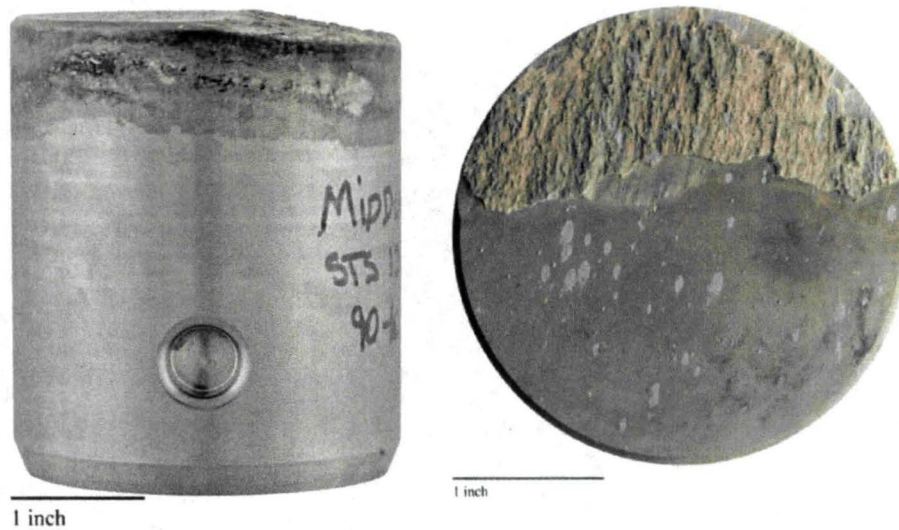
- 3.1 The submitted samples were photographed as-received (Figures 1-11). The severity of erosion varied by sample and by location on the SRB main flame deflector. The tungsten pistons displayed more erosion after STS-134 than in the previous STS-133 launch (Figures 4-6). Both of the 304 stainless steel caps displayed significant material loss (Figures 7 and 8). The customer reported that the Medtherm Calorimeter embedded in the top cap was eroded by the SRB plume at about 1.6 seconds into the event. The Medtherm calorimeter is water cooled and water emitted from the sensor after erosion into the cooling water jacket protected the stainless steel from erosion (Figure 8, arrow). Three piston sleeves were exposed to the launches of STS-133 and STS-134 with corresponding erosion from different orientations (Figures 9-11).

Figure 5. Middle tungsten piston, as-received, profile (left) and top (right).  
Scale is one inch.

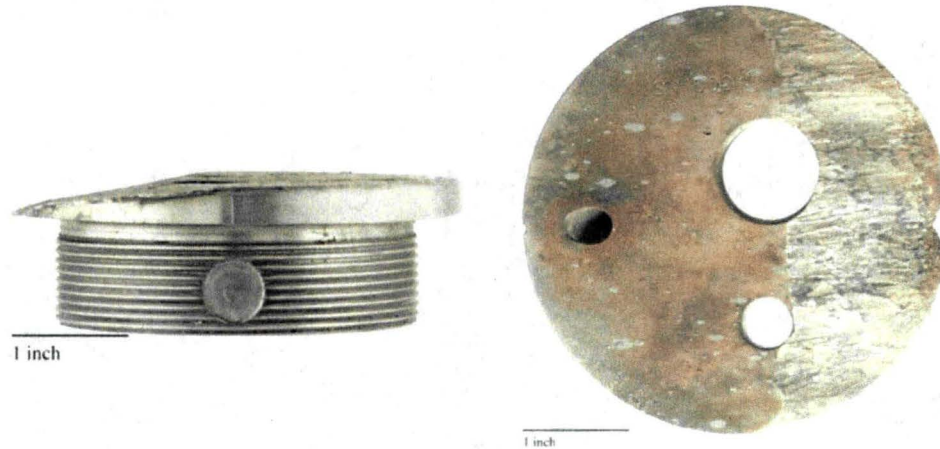
Figure 7. Middle 304 stainless steel cap, as-received, profile (left) and top (right). Scale is one inch.

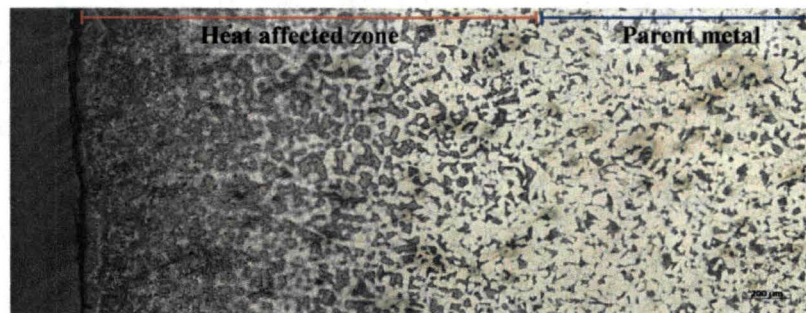
- 3.3. The three 1018 witness rod samples were cross-sectioned at the 12 o'clock positions, mounted in acrylic resin, and prepared for metallographic examination. The three samples showed varying degrees of microstructural changes due to the heating of the metal during launch, followed by quenching due to the water deluge. The heat affected zones in the top and bottom samples at the 12 o'clock position consisted of a transition to untempered martensite with possible minor amounts of bainite at the edge of the samples from the ferrite and pearlite grains in the parent metal (Figures 12, 13, and 14). The heat affected zone in the middle sample at the 12 o'clock position did not display a microstructure that was affected by heat as much as the other two samples. The ferrite and pearlite grains were still present, but additional carbides formed in the microstructure at the surface (Figures 15 and 16). The heat affected zone was approximately 0.08 inch (2 mm) deep in the bottom sample, 0.06 inch (1.5 mm) deep in the top sample, and only 0.008 inch (0.2 mm) deep in the middle sample. High magnification observation at the surface of the witness rod revealed no apparent indications of melted metal, such as dendrites or distorted grains (Figures 14 and 16). The possibility of melting is not likely, but could not be eliminated because the melted metal could have ablated from the surface due to the launch blast.

Figure 13. Micrograph of the surface of the top sample 1018 witness rod showing the martensite with possible minor amounts of bainite in the heat affected zone transitioning to ferrite and pearlite in the parent metal. Note: Surface of the witness rod is on the left. Etchant: 2% nital. Original magnification: 100X
